Project Profile

Australian mine saves time and cost with Dur-A-Span aluminum culvert reline under rail corridor

Project Name: CD2E Culvert Reline

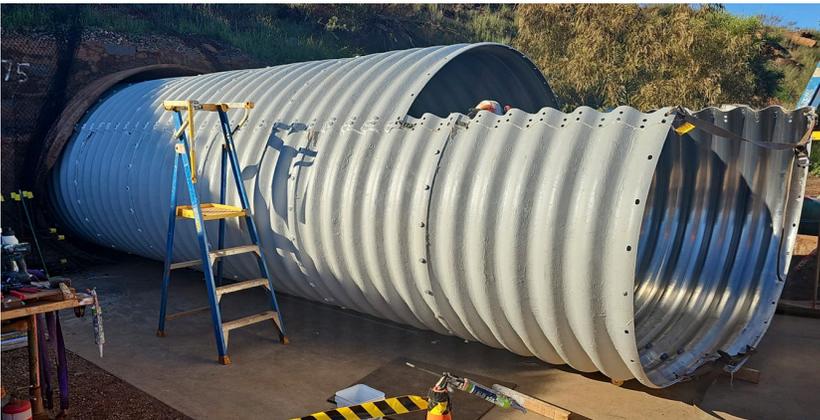
A Rio Tinto mine site in Western Australia extended the life of an aging stormwater management culvert running under an active rail corridor by opting for a slip-line reline of the old culvert using an AIL Dur-A-Span Aluminum Structural Plate Pipe Arch. This avoided the need for a costly replacement with an operational shutdown.

Dimensions: Span 3.06 m, Rise 2.31 m,
Length 67.2 m

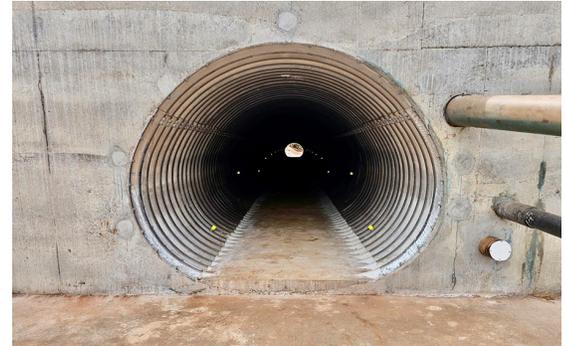
DCI Group developed a comprehensive work plan that addressed the access constraints through innovative installation methodologies. The team engineered a radical solution that streamlined the installation process to work within the limited time windows while prioritizing worker safety. This approach enabled the slip line installation to be completed under an active rail line without requiring any train service interruptions. The solution not only created safer working conditions by minimizing time spent in the restricted zone but also significantly expedited the overall installation timeline, with the complete slip line assembled and installed in just nine days despite the challenging constraints.
